# **BREAKNECK DAM**

## **NJ 00425**

**PHASE 1 INSPECTION REPORT**  
**NATIONAL DAM SAFETY PROGRAM**

May, 1979

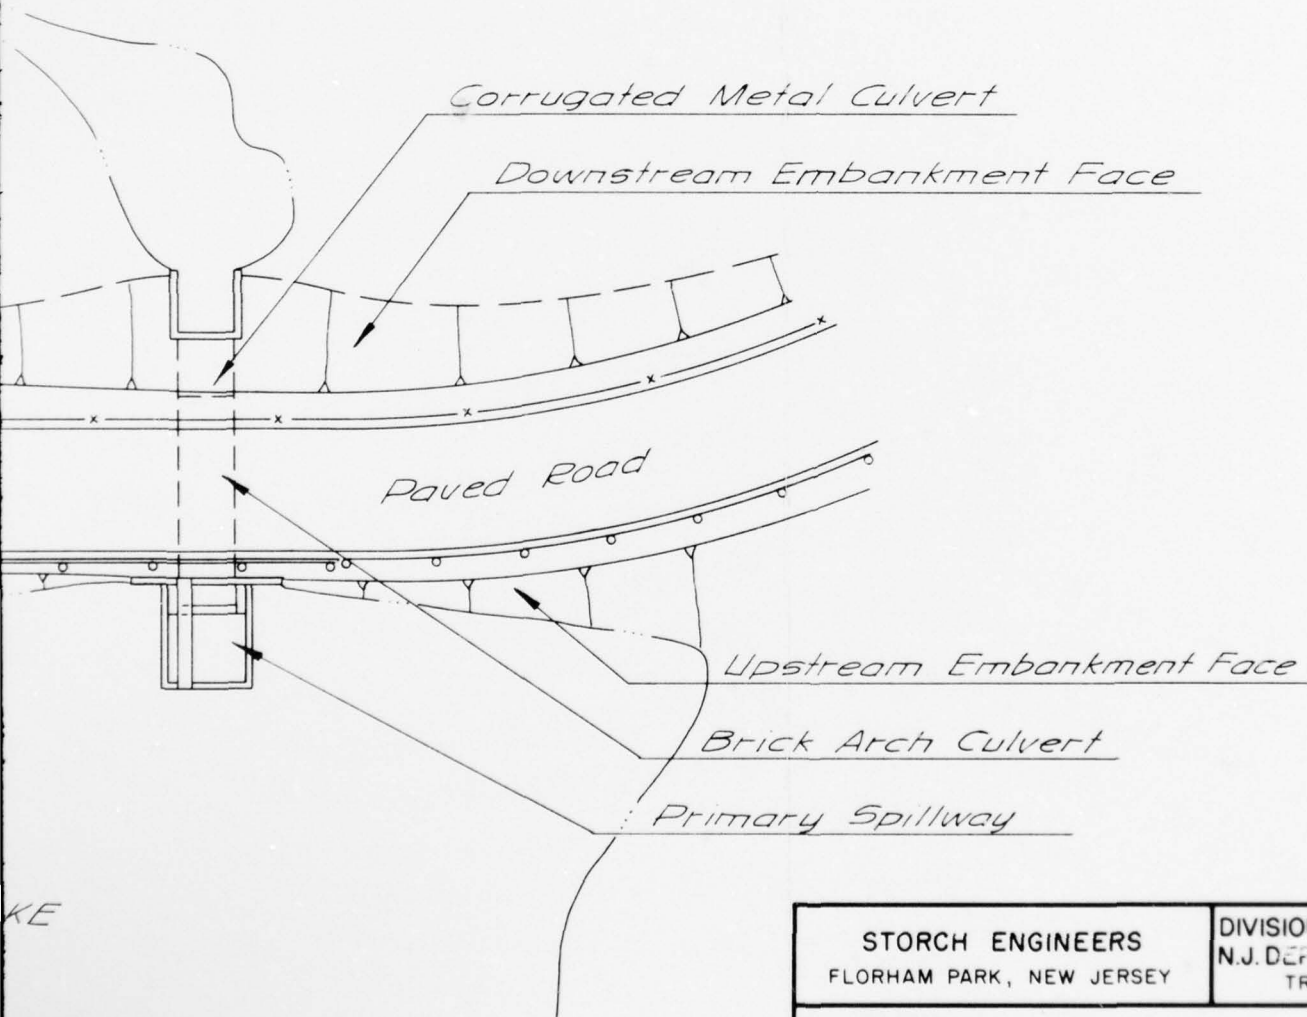
PLATE 5

A stilling basin was observed at the outfall of the secondary spillway discharge culvert. The west bank of the natural channel downstream of this outfall has been undercut and eroded. Seepage was noted exiting from the undercut area (see Plate 5 and Photo 9) discharging as a trickle with some suspended orange silt.

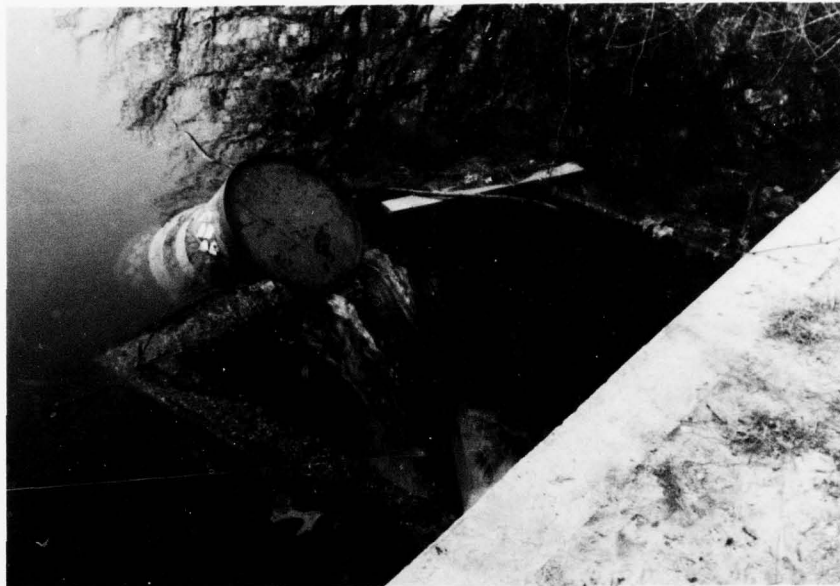
PHOTO 3

The facilities at Breakneck Dam consist of an earthfill embankment with two concrete box drop inlet spillways. (see Plate 5, Overview Photo and Photos 1 and 3) The spillways discharge into culverts that pass through the embankment and outfall at the downstream toe of the embankment (see Photos 2 and 4).

SECONDARY SPILLWAY

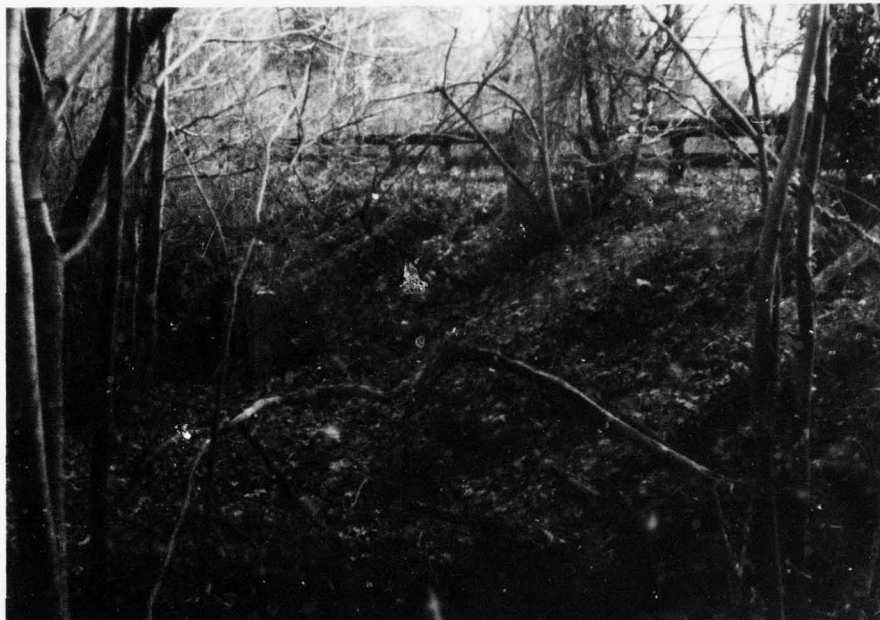
PHOTO 5

The earthfill embankment is approximately 255 feet long and extends east/west. The embankment crest is 33 feet wide with an asphalt roadway at its center, about 21 feet wide (see Plate 8 and Photo 6). Based on field measurements, the upstream and downstream slopes are approximately 1:1 (see Photo 5). The embankment crest is generally level at elevation 55.8 (MSL) and the dam is about 14 feet high. Dense vegetation consisting of low level ground cover, brush and trees, covers both the upstream and downstream slopes of the embankment. The surface soil on the embankment consists mainly of sand.

DOWNSTREAM FACE OF DAM
